Client Name: United States Army Corps of Engineers		Site Location: Bradford Island	Project No. 52-00080001.08
Photo No. 1

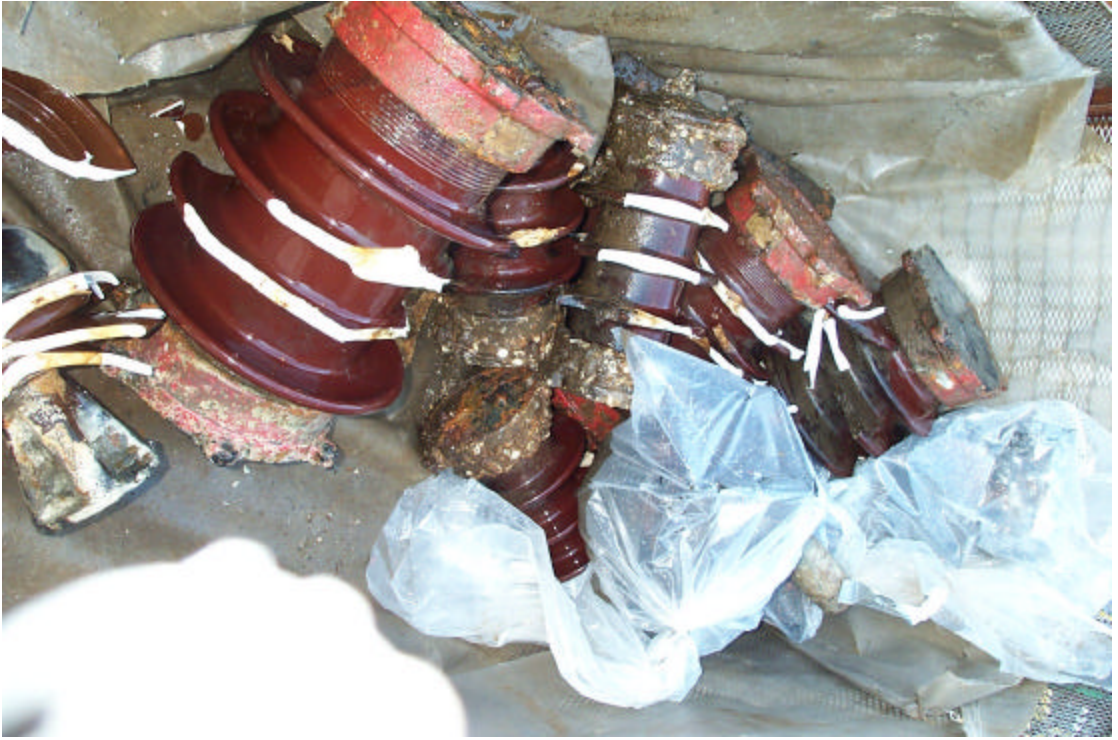
Direction Photo Taken: NA			
Description: Bagged capacitor and coupling capacitors.

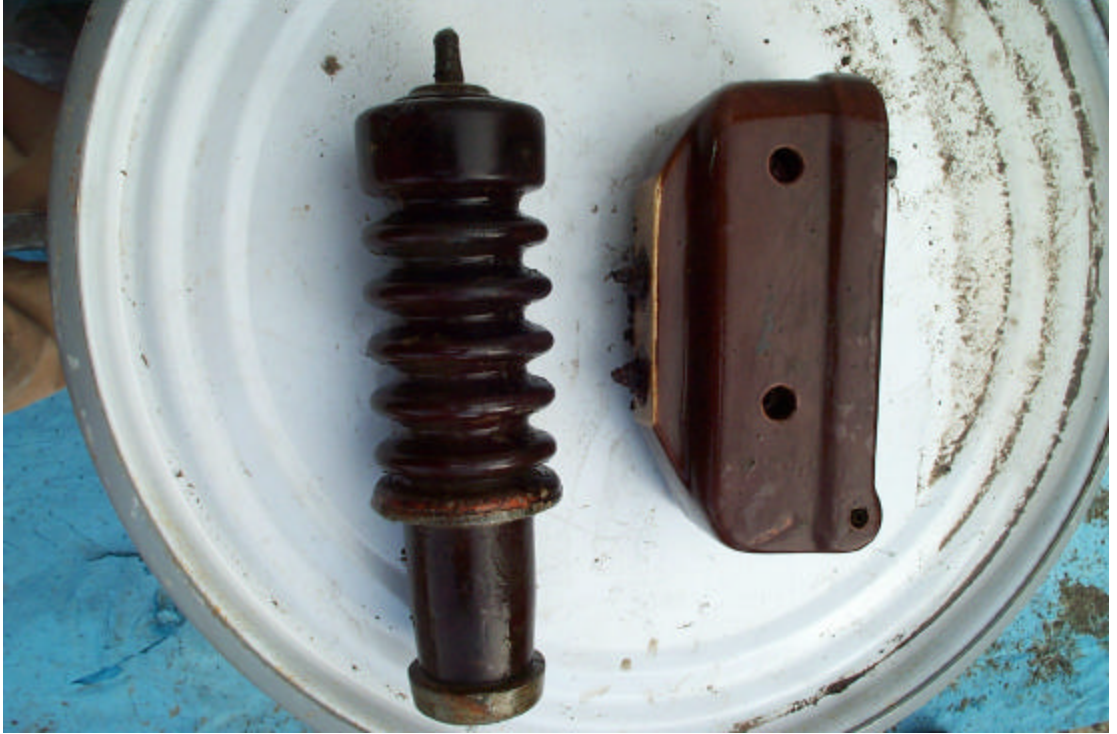
Client Name: United States Army Corps of Engineers		Site Location: Bradford Island	Project No. 52-00080001.08
Photo No. 3

Direction Photo Taken: NA			
Description: Ceramic pieces.

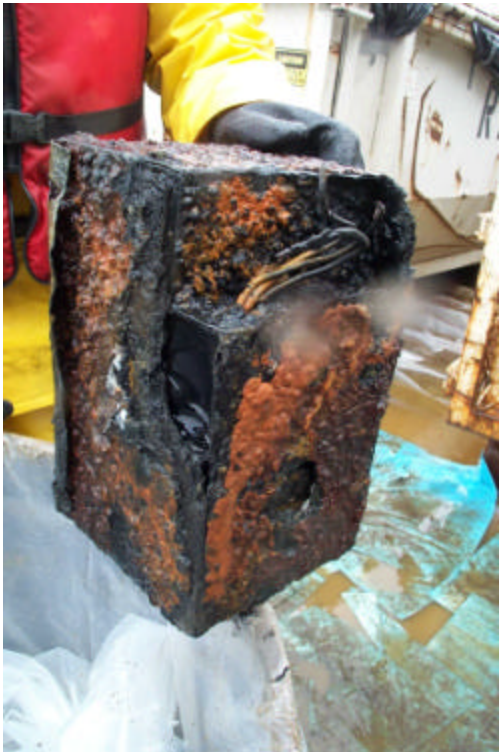
Client Name: United States Army Corps of Engineers		Site Location: Bradford Island	Project No. 52-00080001.08
Photo No. 5

Direction Photo Taken: NA			
Description: "Black Box" ballast.

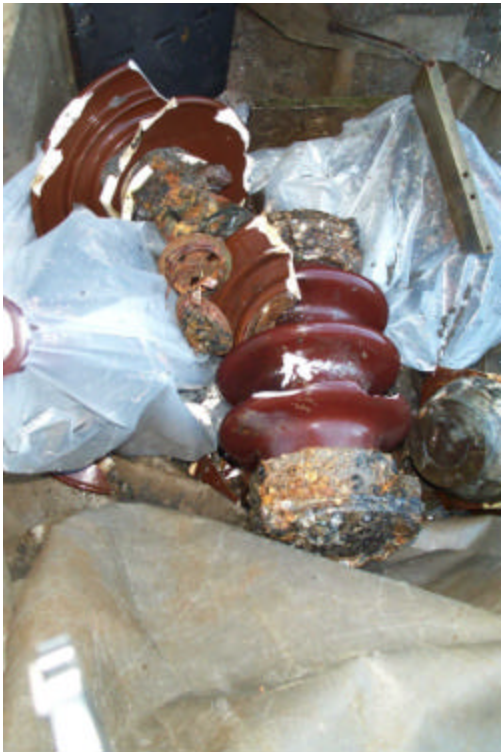
Client Name: United States Army Corps of Engineers		Site Location: Bradford Island	Project No. 52-00080001.08
Photo No. 7

Direction Photo Taken: NA			
Description: Bagged capacitors and lightning arrester in box.

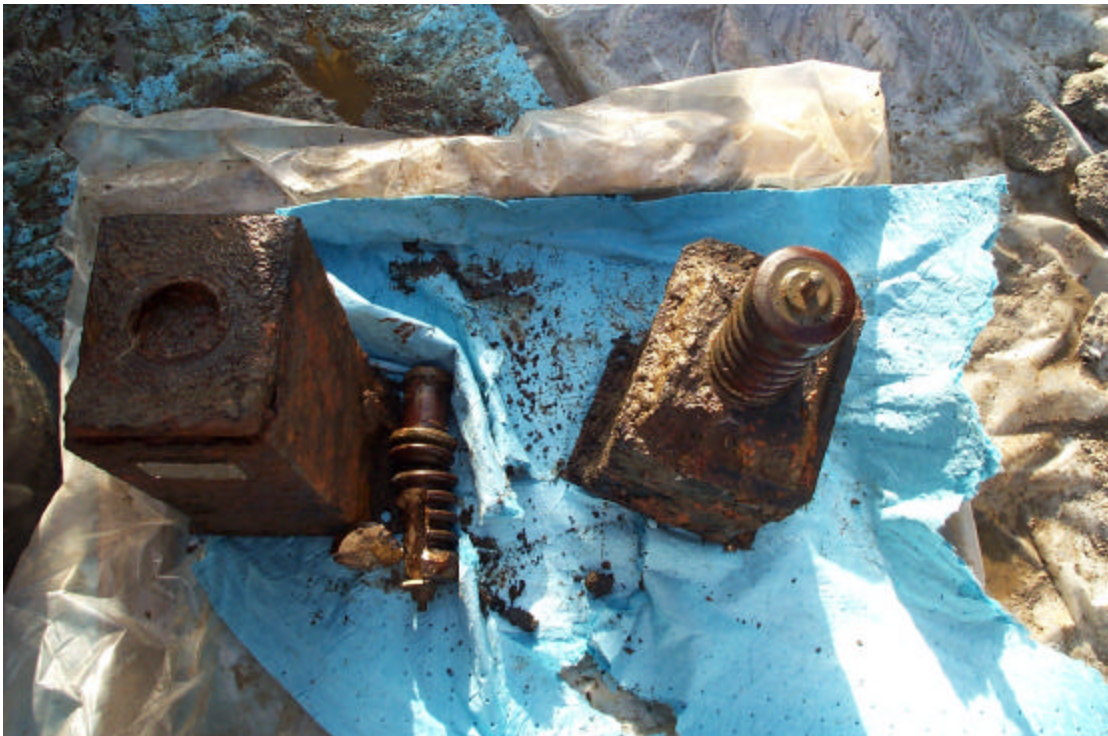
Client Name: United States Army Corps of Engineers		Site Location: Bradford Island	Project No. 52-00080001.08
Photo No. 9

Direction Photo Taken: NA			
Description: Inerteen capacitors.

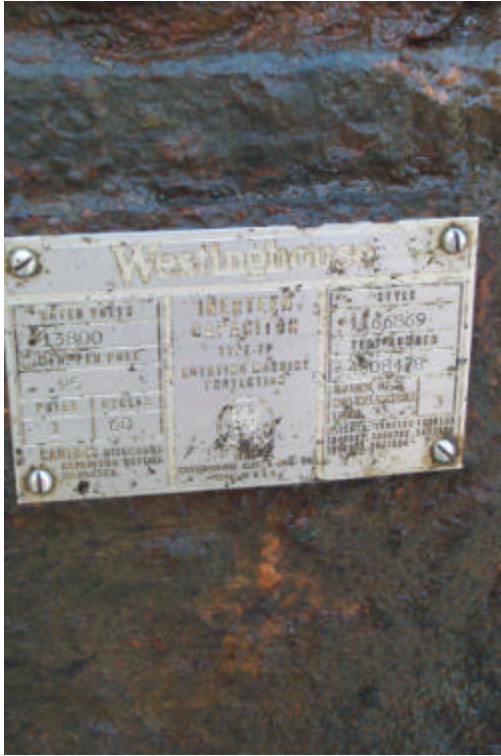
Client Name: United States Army Corps of Engineers		Site Location: Bradford Island	Project No. 52-00080001.08
Photo No. 11

Direction Photo Taken: NA			
Description: Closeup of label from an interteem capacitor.

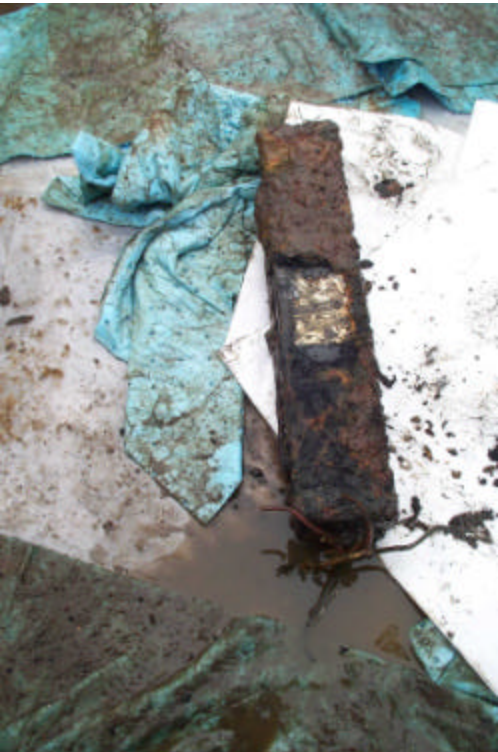
Client Name: United States Army Corps of Engineers		Site Location: Bradford Island	Project No. 52-00080001.08
Photo No. 13

Direction Photo Taken: NA			
Description: Light ballast.

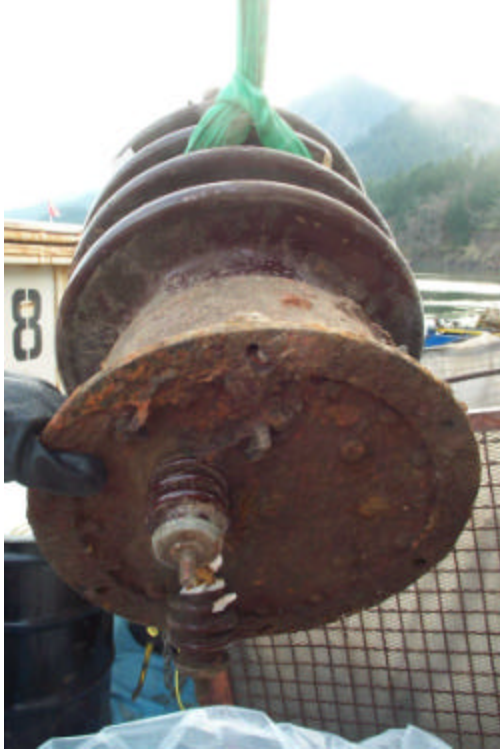
Client Name: United States Army Corps of Engineers		Site Location: Bradford Island	Project No. 52-00080001.08
Photo No. 15

Direction Photo Taken: NA			
Description: Top view of a coupling capacitor.

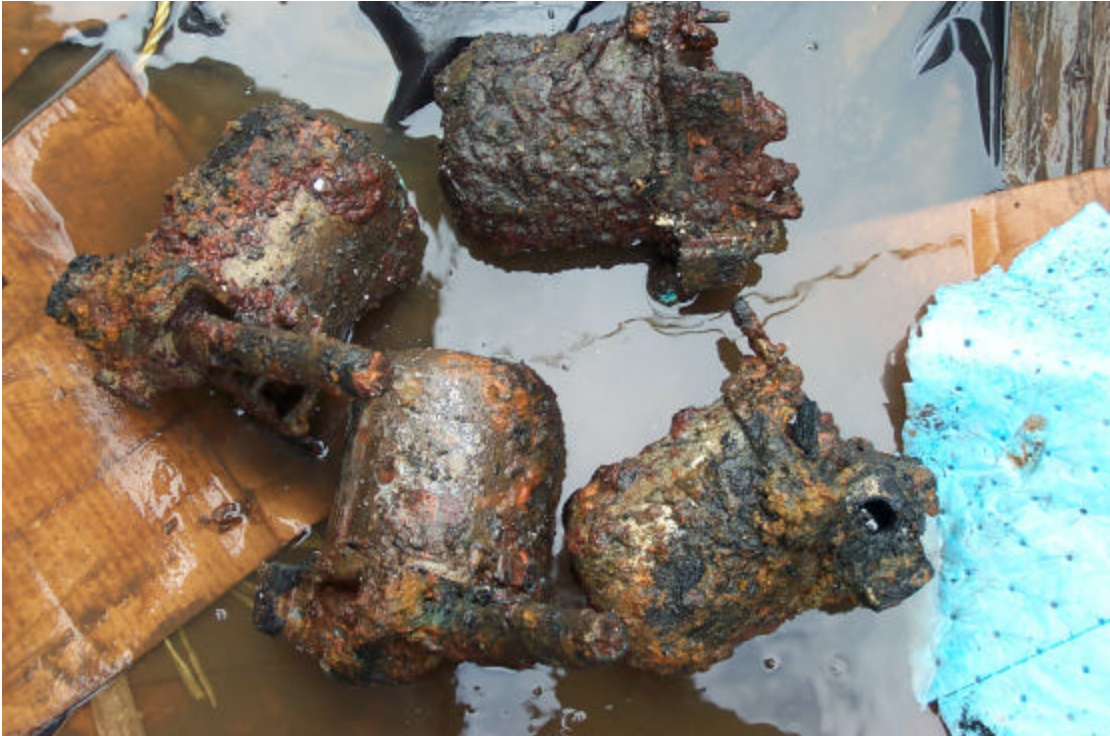
Client Name: United States Army Corps of Engineers		Site Location: Bradford Island	Project No. 52-00080001.08
Photo No. 17

Direction Photo Taken: NA			
Description: Oil-filled switches.

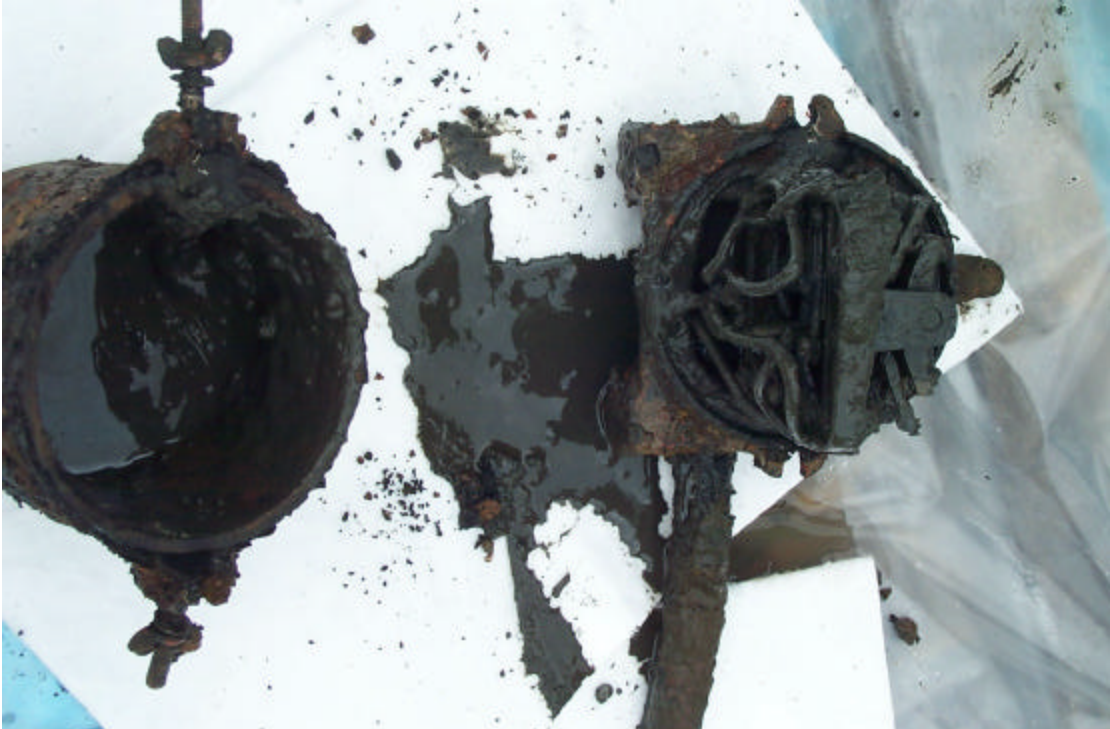
Client Name: United States Army Corps of Engineers		Site Location: Bradford Island	Project No. 52-00080001.08
Photo No. 19

Direction Photo Taken: NA			
Description: Opened oil-filled switch.

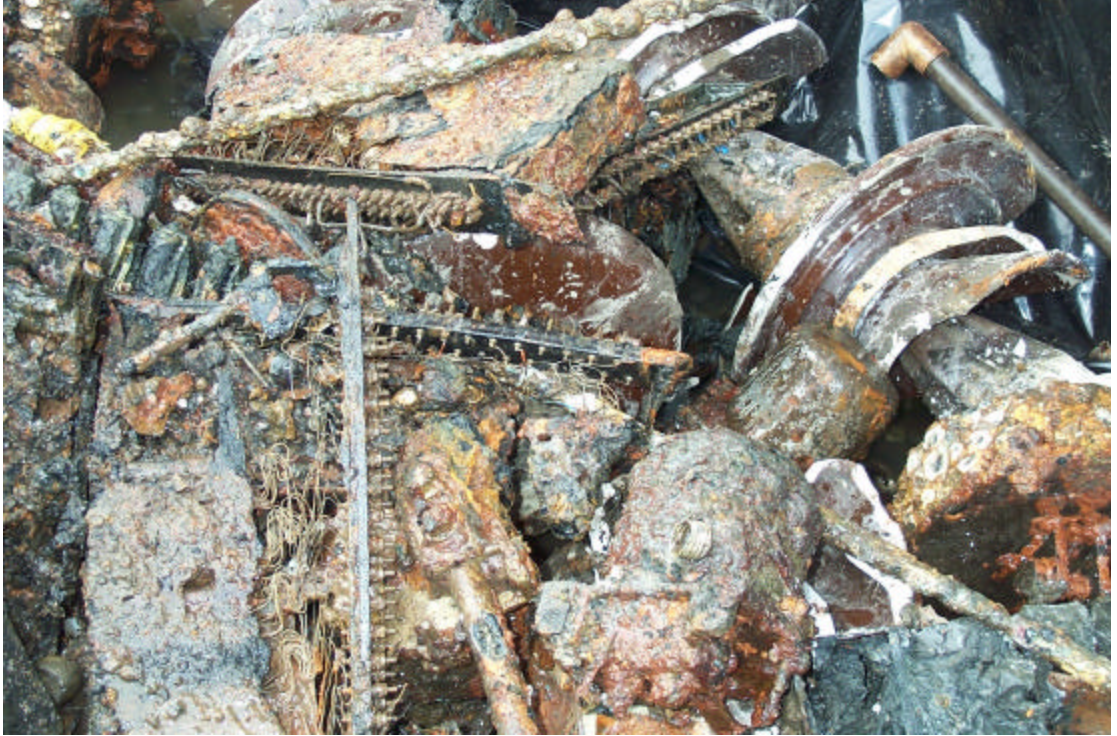
Client Name: United States Army Corps of Engineers		Site Location: Bradford Island	Project No. 52-00080001.08
Photo No. 21

Direction Photo Taken: NA			
Description: Communication boxes and post insulator.

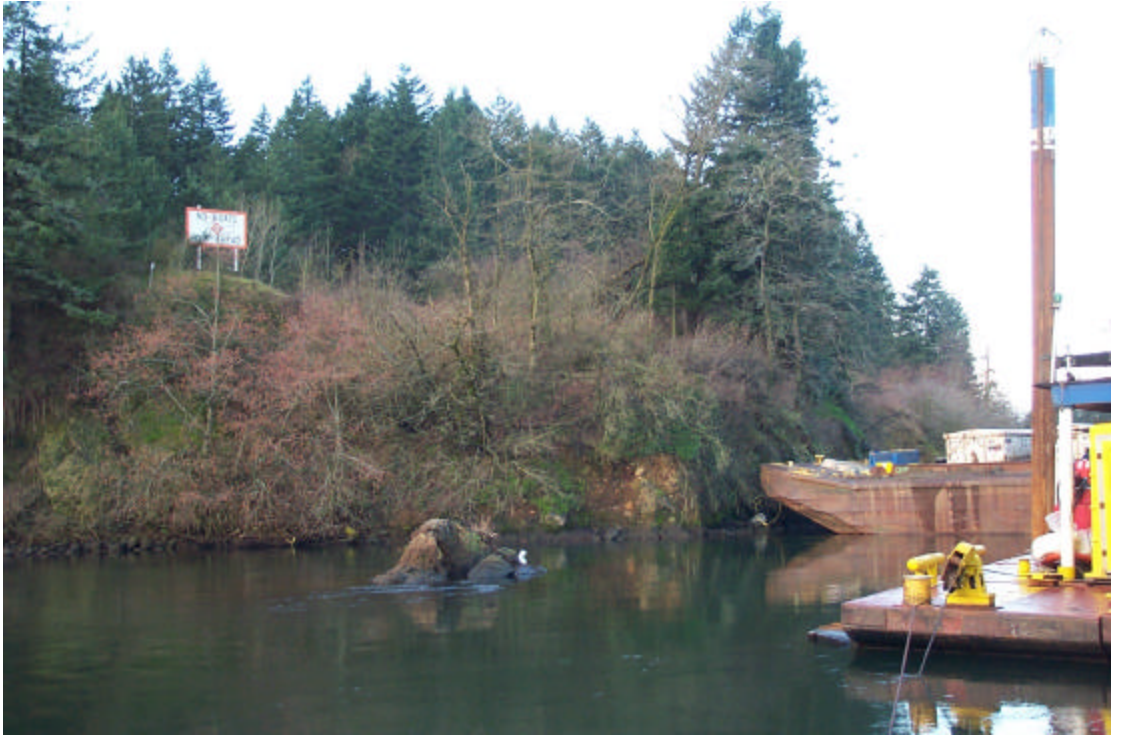
Client Name: United States Army Corps of Engineers		Site Location: Bradford Island	Project No. 52-00080001.08
Photo No. 23

Direction Photo Taken: West			
Description: Barge set up on Pile #1.

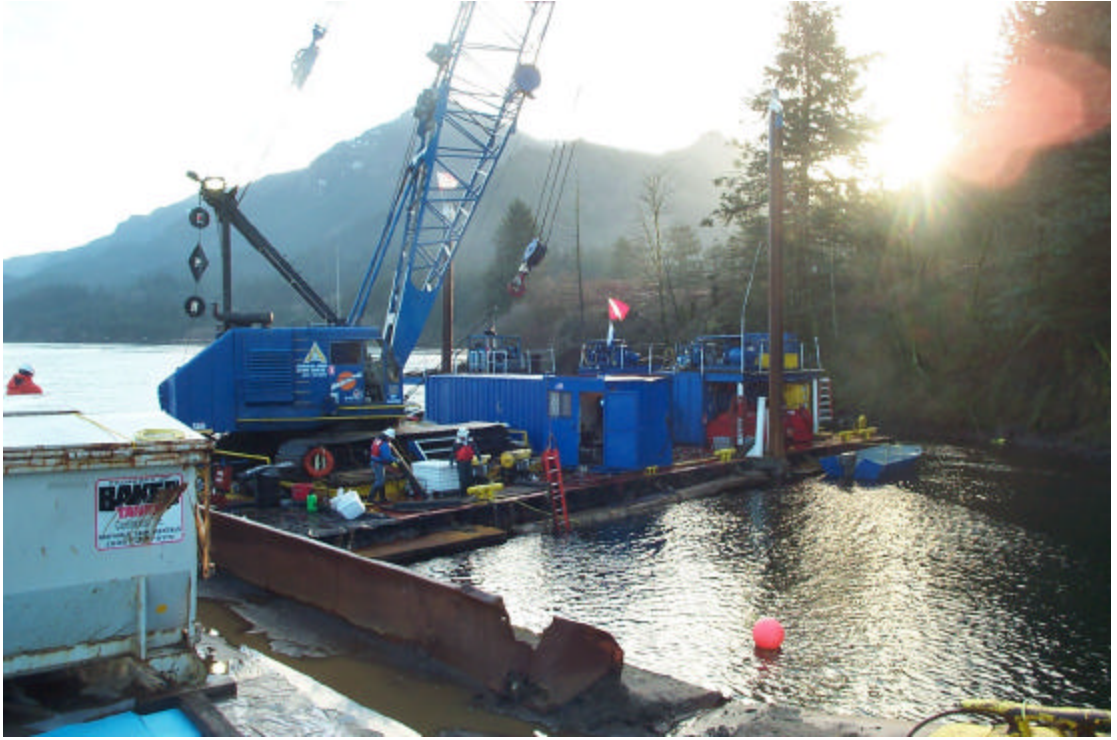
Client Name: United States Army Corps of Engineers		Site Location: Bradford Island	Project No. 52-00080001.08
Photo No. 25

Direction Photo Taken: East			
Description: Barge set up on Pile #3.

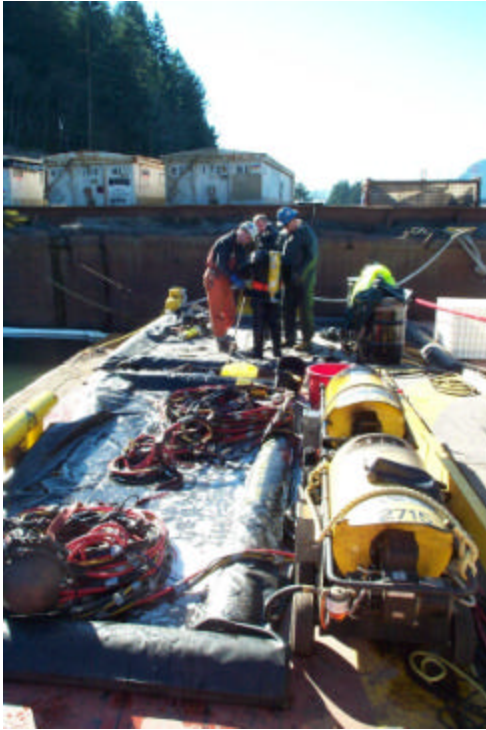
Photo No. 26

Direction Photo Taken: West			
Description: Diver decon area and materials barge in background.

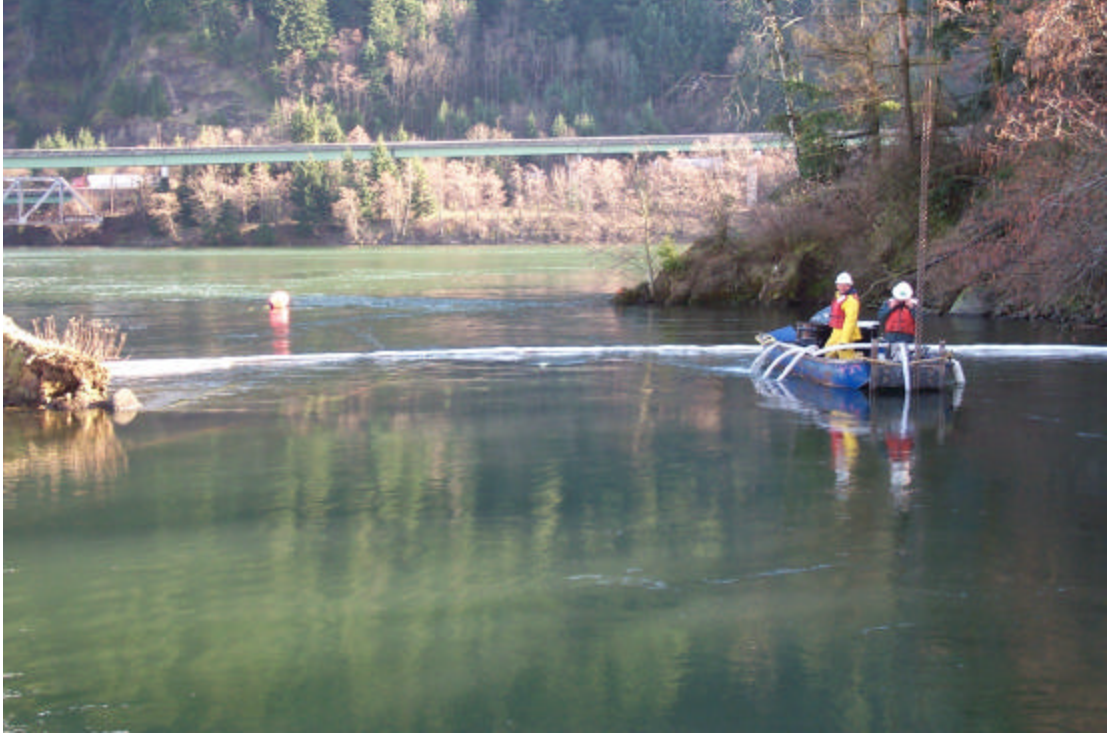
Client Name: United States Army Corps of Engineers		Site Location: Bradford Island	Project No. 52-00080001.08
Photo No. 27

Direction Photo Taken: South			
Description: Sediment removal at Pile #1.

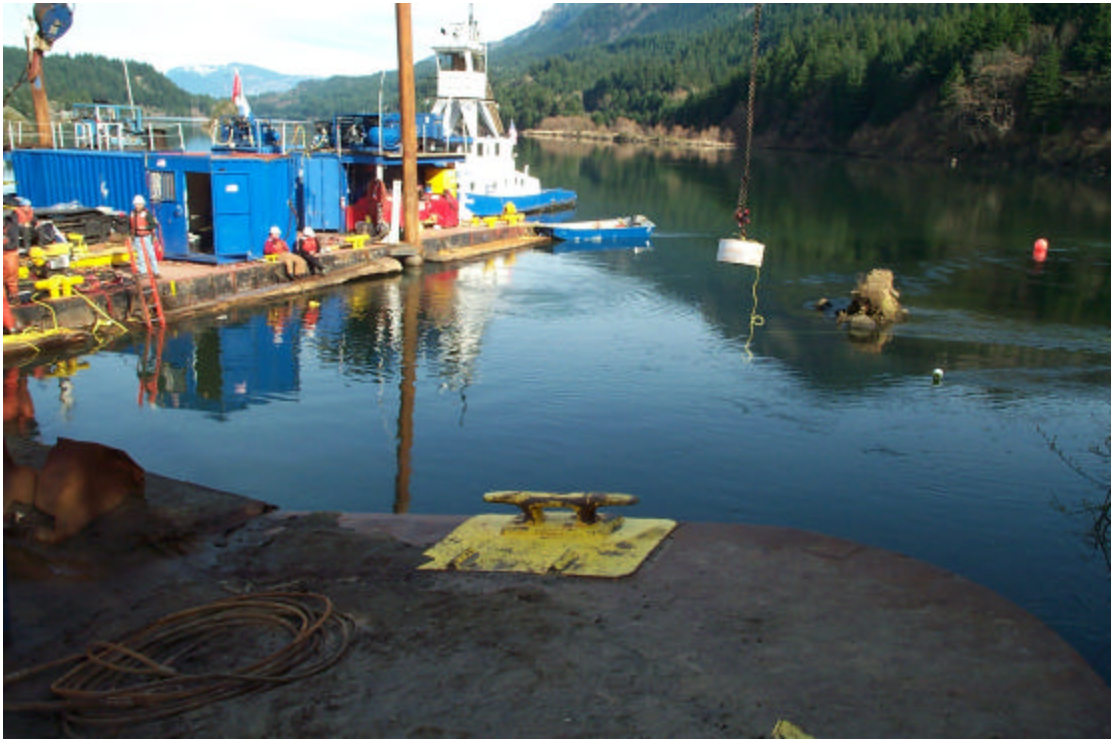
Client Name: United States Army Corps of Engineers		Site Location: Bradford Island	Project No. 52-00080001.08
Photo No. 29

Direction Photo Taken: East			
Description: Placing anchors at Pile #1.

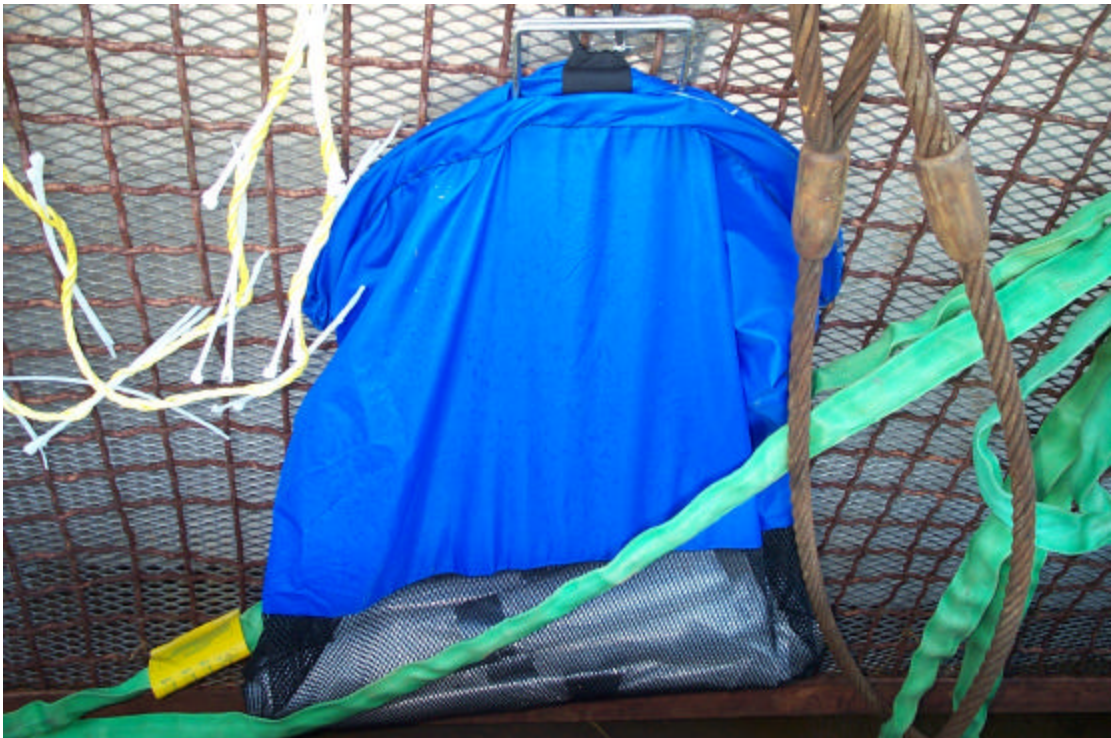
Client Name: United States Army Corps of Engineers		Site Location: Bradford Island	Project No. 52-00080001.08
Photo No. 31

Direction Photo Taken: NA			
Description: Closeup of lined wire basket and goody bag.

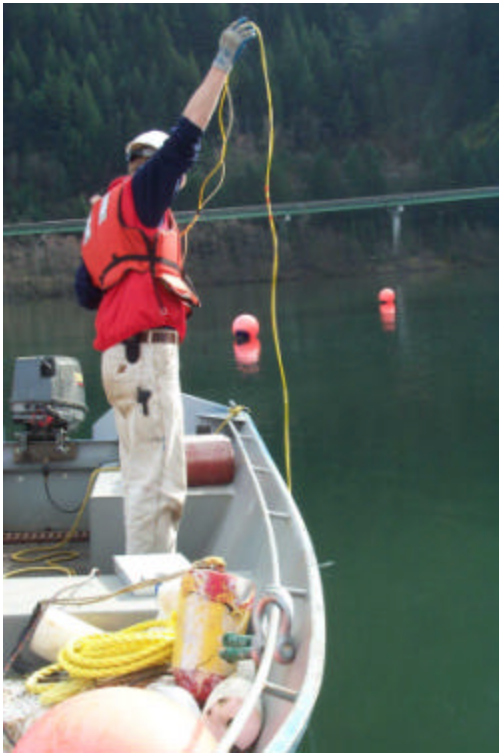
Client Name: United States Army Corps of Engineers		Site Location: Bradford Island	Project No. 52-00080001.08
Photo No. 33

Direction Photo Taken: South			
Description: Placing turbidity probe in water.

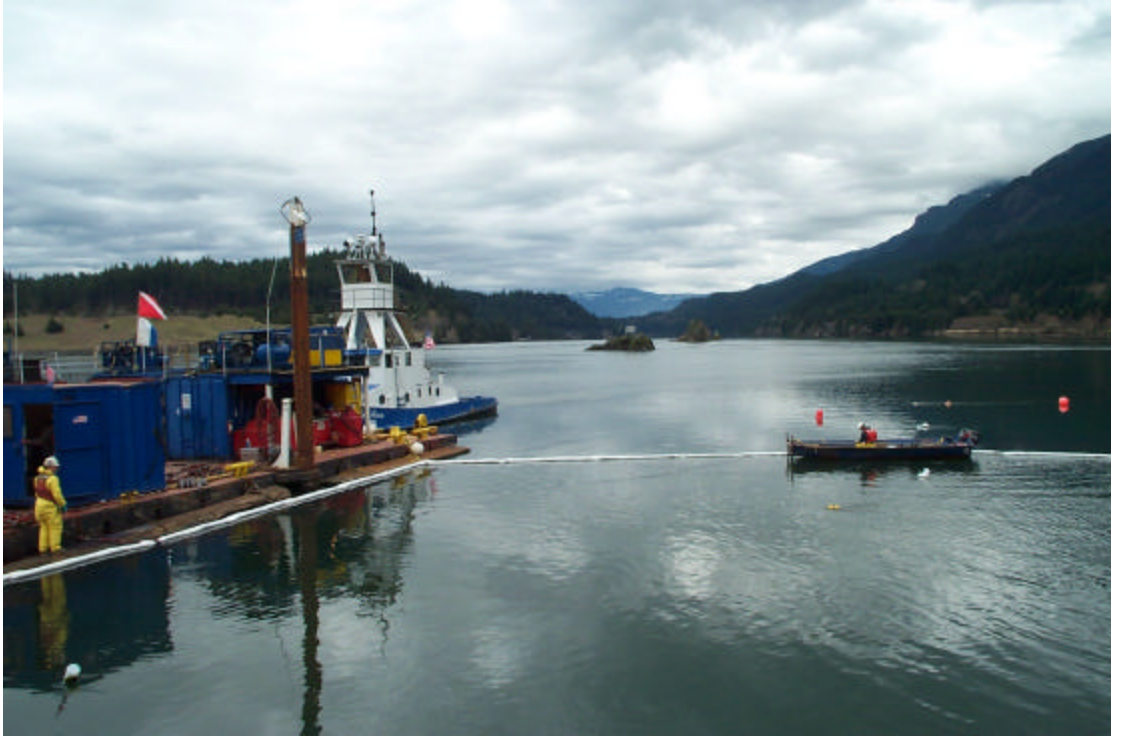
Client Name: United States Army Corps of Engineers		Site Location: Bradford Island	Project No. 52-00080001.08
Photo No. 35

Direction Photo Taken: East			
Description: Turbidity monitoring at Pile #1.
